**ALLSTAR PZL GLIDER**  
ul. Cieszyńska 325  
43-300 Bielsko-Biała  
Poland

# SERVICE BULLETIN BE-004/54-2/2026

**SAILPLANE:** Type SZD-54 „Perkoz”, model SZD-54-2 „Perkoz”

1. Inspection of the airbrake driving torsional tube.
2. Procedure to follow if damage to the torsional tube is detected.

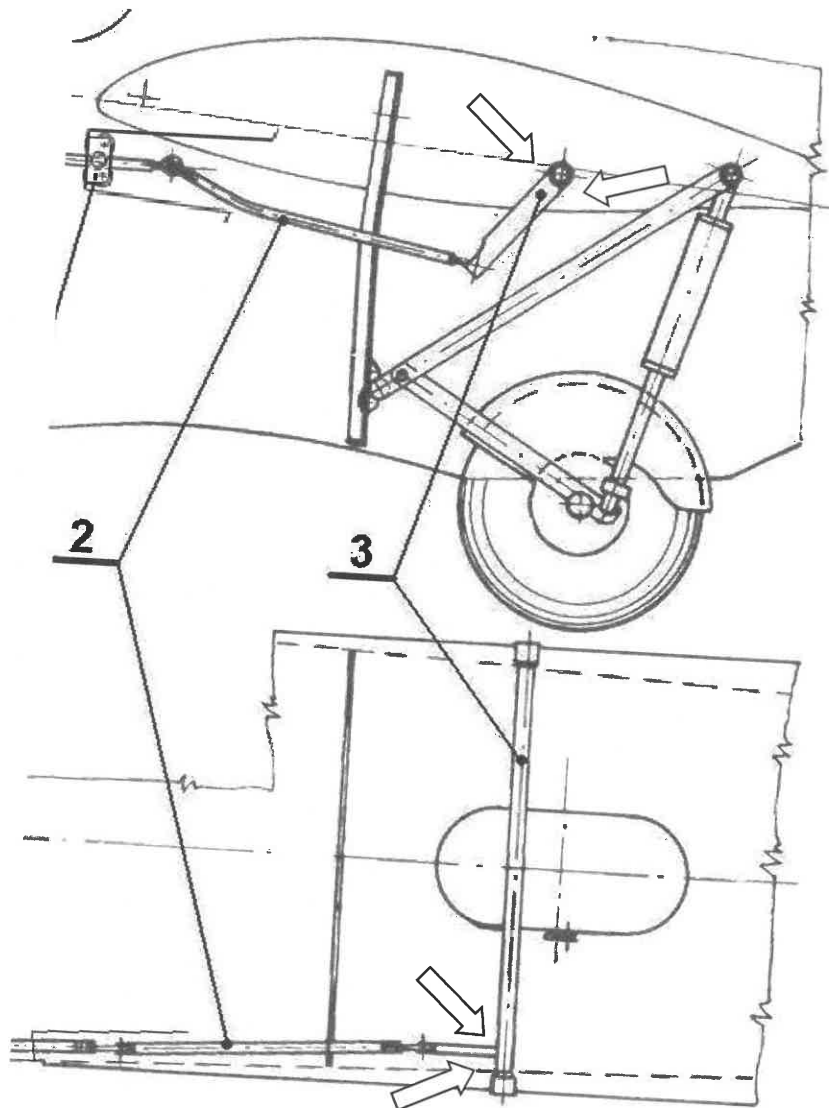
- 3.1.1. Remove the wings according to the procedure described in the Technical Service Manual, section 2.1, or the Flight Manual, section 4.
- 3.1.2. Using a mirror and a strong light source (flashlight), visually inspect the area where the lever is welded to the torsional tube (item 3 in Figure 1 and the areas susceptible to cracking, as indicated in Figure 2).
- 3.1.3. After inspection, reassemble the wings according to the procedure described in the Technical Service Manual, Section 2.1, or the Flight Manual, Section 4.

Figure 1 – location of the torsion tube (3) of the airbrake drive in the fuselage. The arrows indicate the areas being checked, shown in more detail in Figure 2.

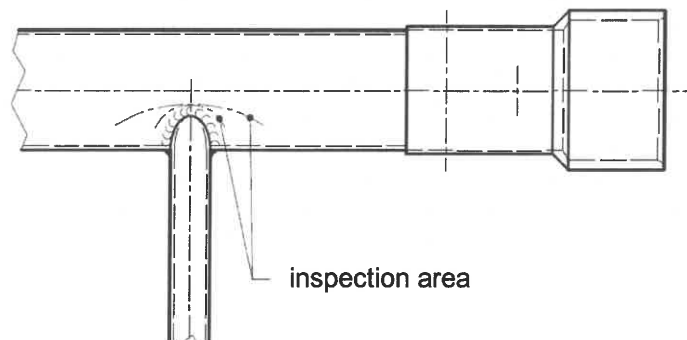
Allstar PZL Glider, the holder of the Type Certificate for the SZD-54 "Perkoz" sailplane, has received information from operators of the above-mentioned gliders about the appearance of cracks at the connection of the lever with the torsional tube of the airbrake drive mounted in the fuselage (elements 02 Arm and 01 Connector in drawing 540.64.30.00).

Structural failure or disconnection of the drive components connection may prevent the operation of airbrakes, which could lead to hazardous flight situations.

Figure 2 – connection of the lever to the torsional tube of the airbrake control with indication of areas where cracks may appear (on both sides).

- 3.2.1. With the wings and rear baggage compartment floor removed, remove the airbrake drive torsional tube assembly.
- 3.2.2. Using a magnifying glass with at least 3x magnification, inspect that there are no cracks in the weld area and around the welded lever-tube joint (Figure 2).
- 3.2.3. If necessary, perform defectoscopy of the areas to be checked - Dye Penetrant Inspection (DPI).
- 3.2.4. Visually check that the tube has retained its cylindrical shape and that there are no permanent deformations.

- 4.1. If damage to the connection between the lever and the torsional tube is found, the sailplane should be withdrawn from service until the sailplane manufacturer's recommendations (currently under development) are implemented.
- 4.2. If the inspection reveals no damage to the lever-torsional tube connection, the sailplane can be still operated in accordance with the inspection intervals described in point 3.3.
