SERVICE BULLETIN No BE-010/SZD-59/2009 "ACRO"

DESIGNATION-TYPE/MODEL: SZD-59 "ACRO"

CONCERNS: Inspection of the fuselage frame joints.

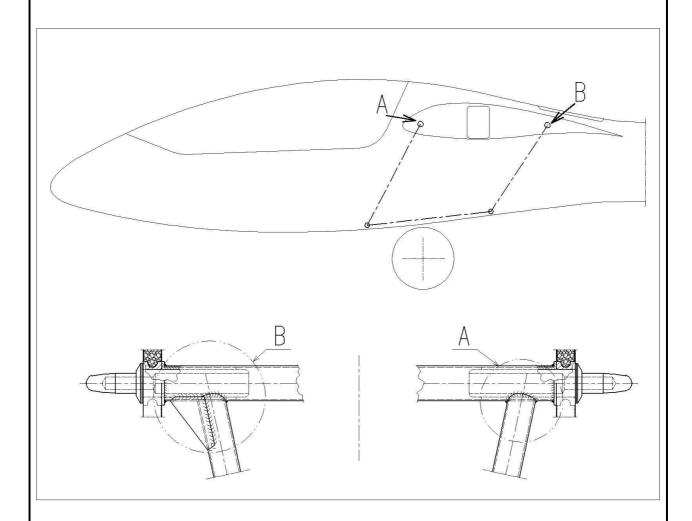
Fig.1. Cracks location.

In 4 SZD-59 gliders a cracks of the fuselage frame tube has been detected, at the front wing fixing point, near welded joint.

By the cockpit's cutout the front frame tube at welded joints, next to the front wing fixing pivots (see Fig.1, A)is to be inspected by visual methods. All circumference of the tube is to be inspected. By the sighthole between wings, rear frame tube is to be inspected, at the welded joints (see Fig.1, B). All circumference of the tube is to be inspected. For rear tube inspection, tools like a digital camera, endoscope or similar can be necessary. In a case of a crack is found, the glider is to be found non-airworthy until a repair is done, and the operator of a glider is requested to report the case to the manufacturer. Please enclose following information: serial number of the glider, total flight time and total amount of landings.

- 5.1. The inspection of the front tube is to be repeated before every day of flying. The inspection of the rear tube is to be repeated after each 5 flying days.
- 5.2. The repair method will be given by a separate bulletin.
