**ALLSTAR PZL GLIDER**

## SERVICE BULLETIN BE-004/54-2/2026

- SAILPLANE:** Type SZD-54 „Perkoz”, model SZD-54-2 „Perkoz”.
- SERIAL NUMBERS  
AFFECTED:** All sailplanes of the SZD-54 "Perkoz" type, model SZD-54-2 "Perkoz", up to and including serial number 542.A.25.049.
- SUBJECT:**
1. Inspection of the airbrake driving torsional tube.
  2. Procedure to follow if damage to the torsional tube is detected.
- COMPLIANCE  
TIME:** Upon receipt of this Service Bulletin.

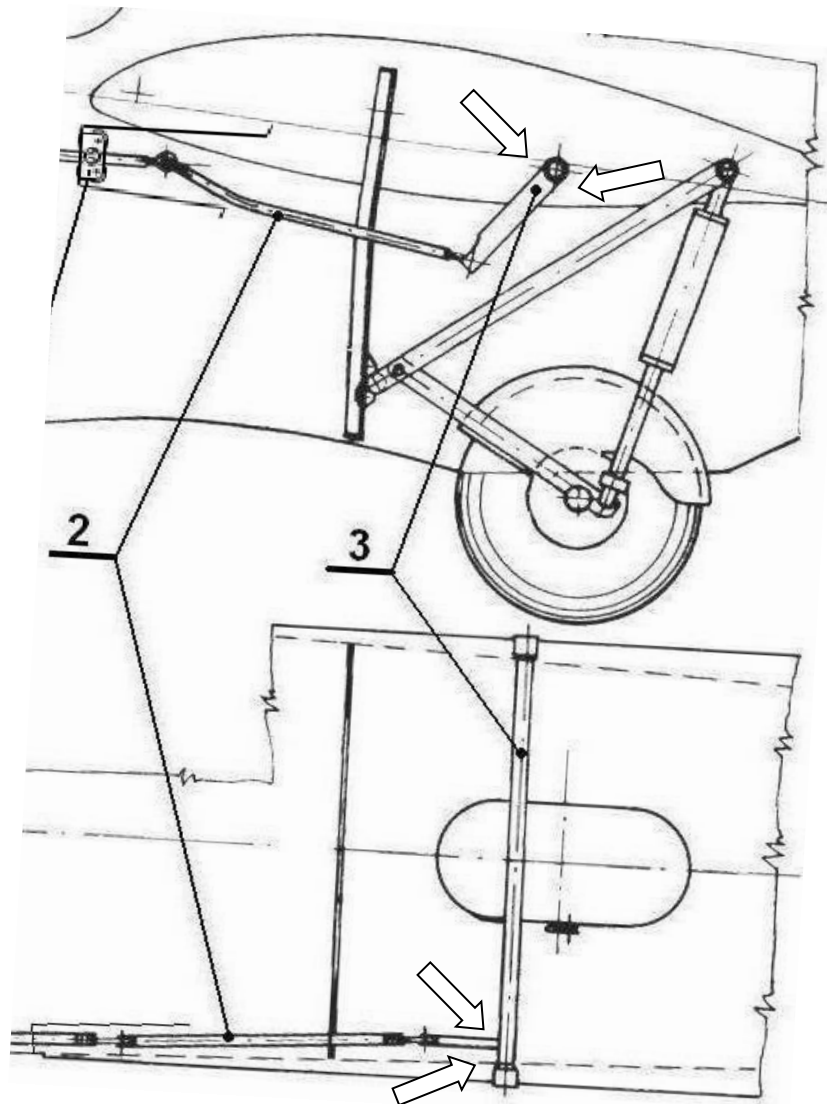
1 | Cracks or permanent deformation of the tube and lever (in the area where these components join) or cracks of the welds are not permitted (Figures 1 and 2).

- 3.1.1. Remove the wings according to the procedure described in the Technical Service Manual, section 2.1, or the Flight Manual, section 4.
- 3.1.2. Using a mirror and a strong light source (flashlight), visually inspect the area where the lever is welded to the torsional tube (item 3 in Figure 1 and the areas susceptible to cracking, as indicated in Figure 2).
- 3.1.3. After inspection, reassemble the wings according to the procedure described in the Technical Service Manual, Section 2.1, or the Flight Manual, Section 4.

Figure 1 – location of the torsion tube (3) of the airbrake drive in the fuselage.  
The arrows indicate the areas being checked, shown in more detail in Figure 2.

- 4.1. If any damage is found, the torsion tube must be replaced with a **new one featuring reinforcements** (consistent with the EASA Major Change Approval No. 10090201).
- 4.2. Once the damaged torsion tube has been replaced with a new, reinforced one, the inspections described in points 3.1 and 3.2 **are not required**; however, the provisions of the Technical Maintenance Manual, Chapter 16, remain in force.
- 4.3. If the inspection reveals no damage to the connection between the lever and the torsion tube (non-reinforced version), the glider may continue to be operated, provided that the inspections described in points 3.1 and 3.2 are carried out in accordance with the inspection intervals set out in point 3.3.

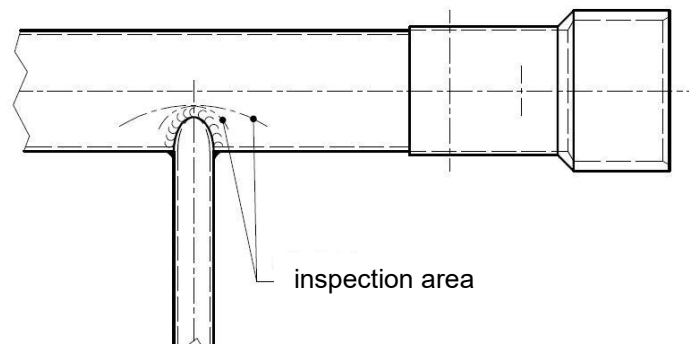
Allstar PZL Glider, the holder of the Type Certificate for the SZD-54 "Perkoz" sailplane, has received information from operators of the above-mentioned gliders about the appearance of cracks at the connection of the lever with the torsional tube of the airbrake drive mounted in the fuselage (elements 02 Arm and 01 Connector in drawing 540.64.30.00).

Figure 2 – connection of the lever to the torsional tube of the airbrake control with indication of areas where cracks may appear (on both sides).

- 3.2.1. With the wings and rear baggage compartment floor removed, remove the airbrake drive torsional tube assembly.
- 3.2.2. Using a magnifying glass with at least 3x magnification, inspect that there are no cracks in the weld area and around the welded lever-tube joint (Figure 2).
- 3.2.3. If necessary, perform defectoscopy of the areas to be checked - Dye Penetrant Inspection (DPI).
- 3.2.4. Visually check that the tube has retained its cylindrical shape and that there are no permanent deformations.
